# CHARACTERISATION OF PINK BIOLOGICAL PATINA IN CALCAREOUS STONE

São João de Almedina church is integrated in Machado de Castro National Museum, located in Coimbra (Portugal). The interior walls the church present a pink patina in several different areas. This walls are made from a sedimentary calcareous stone, of light colour. The texture is compact, with finest grain. The surface is homogeneous and smooth showing the typical hardness of calcite.

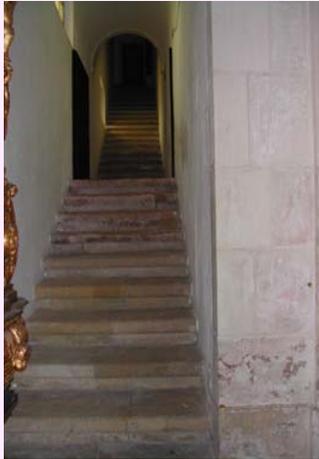
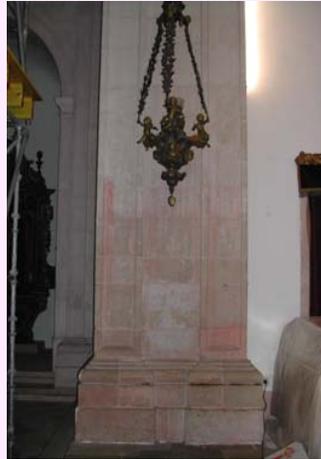
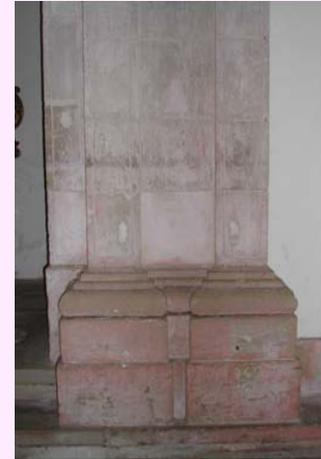
Three different areas, of the internal walls of the church, were selected: one area without pink patina (Area 0) and two areas with patina (Area A and B). In order to determine the colour parameters of the patina and the difference between stone with and without patina, colorimetric measurements were taken. Samples for the qualitative determination of the microorganisms were also collected.

The determination of the colourimetric parameters, CIELab, (Table 1) allowed the distinction between Area 0 and Areas A and B.

The biodiversity is greater in the areas A and B, where the pink patina is present (Table 2). In Area 0 only a few bacteria and yeast were found. Moreover, most of the microorganisms identified in areas A and B were fungi Deuteromycetes.
